Street Audits

Summary Document | El Paso - 2021

In March 2021, street audits were conducted throughout El Paso to gather information about sidewalk conditions, safety perceptions, and driver behavior. One detailed street audit was conducted in each of the eight districts of El Paso.

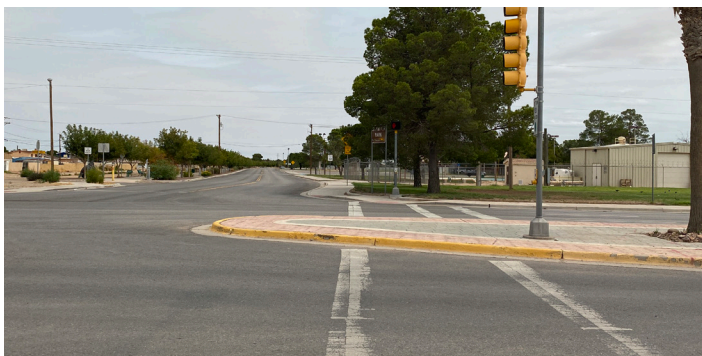
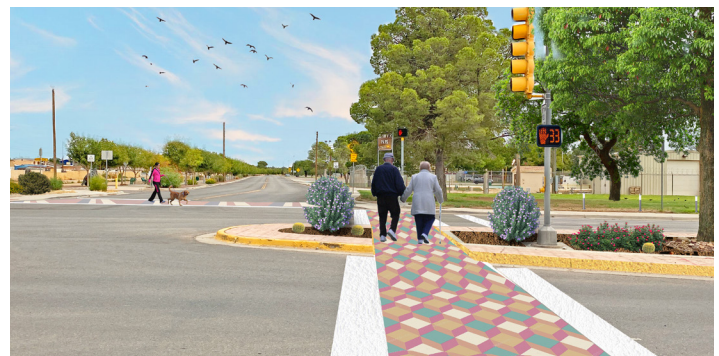
Small changes, such as paint and landscaping, can help address the aforementioned concerns and transform the pedestrian experience (as shown in the renderings below).
