El Paso Complete Streets

Technical Street Audits Report

Prepared by: Quantum Engineering Consultants, Inc.
03/15/2021

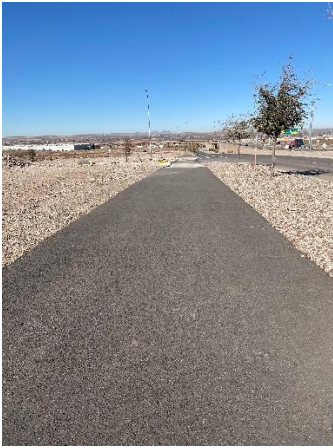
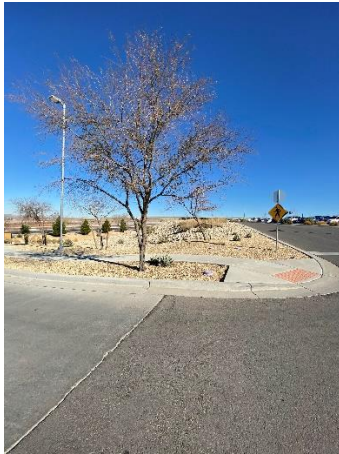
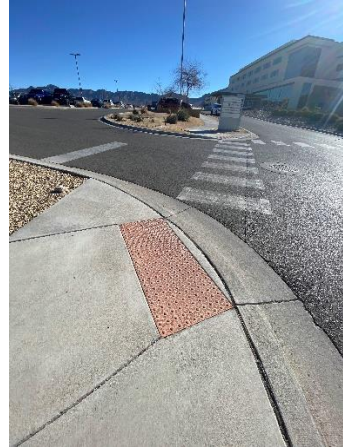
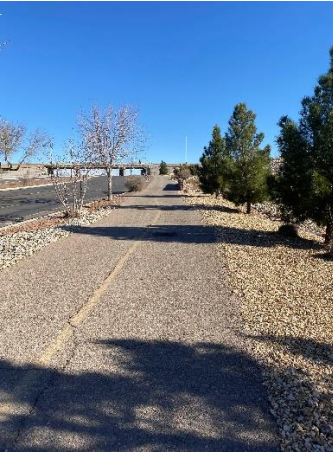
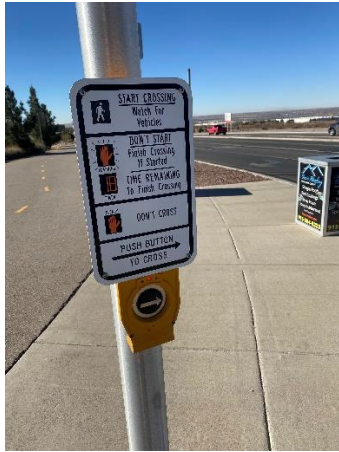
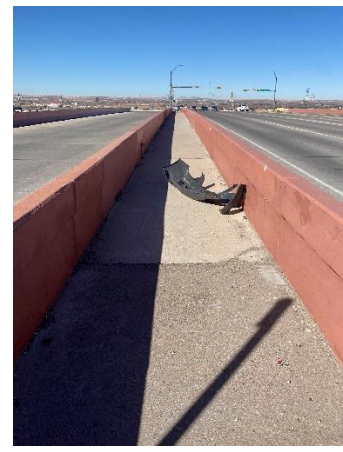
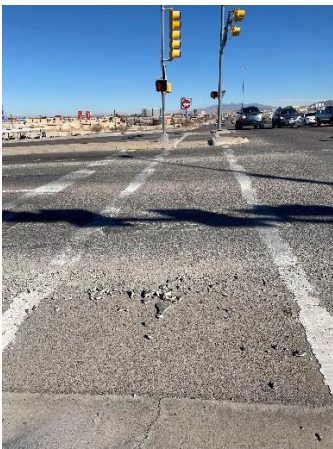
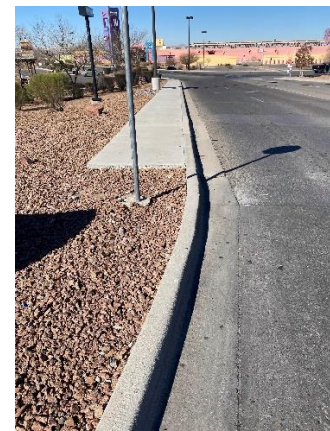
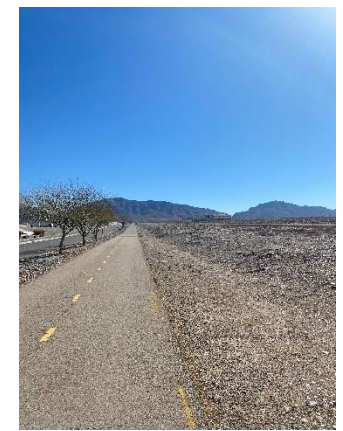
<p>Overall comments</p>	<p>This segment was overall comfortable to walk. However, was extremely uncomfortable at the intersection with the highway (4-way intersection). In addition, there were some cut off walkways/sidewalks once arriving at the outlets that would be impossible for a person in a wheelchair to navigate.</p>

<p>Safety</p>	<ul style="list-style-type: none"> • Car speeds are too fast. • There are no signs at intersections that lack cross walk signals alerting vehicles to other mobility users. Therefore, those crossings are extremely uncomfortable and unsafe.
<p>Overall, the feeling of safety in this area is:</p>	<p>Neutral</p>
<p>Comfort and Appeal</p>	<ul style="list-style-type: none"> • There is not enough shade from canopies, awnings, or trees. • There are not enough street trees or other landscaping. • The street needs benches and places to rest. • The street needs public art and amenities to become more inviting. • Although there is a shared use path, there is no shade, rest stops, or any other amenity to make the walk more comfortable and inviting.
<p>Overall, the comfort and appeal in this area is:</p>	<p>Neutral</p>
<p>Which of the following traffic calming elements would improve safety along your Street Audit route?</p>	<ul style="list-style-type: none"> • Large LED street signs alerting vehicles coming off the highway to other mobility users.

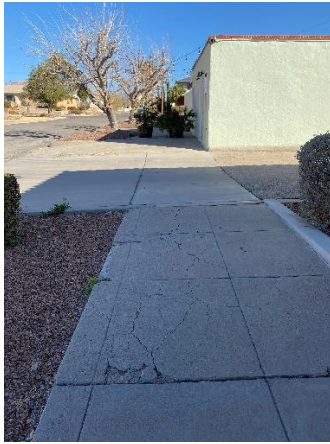
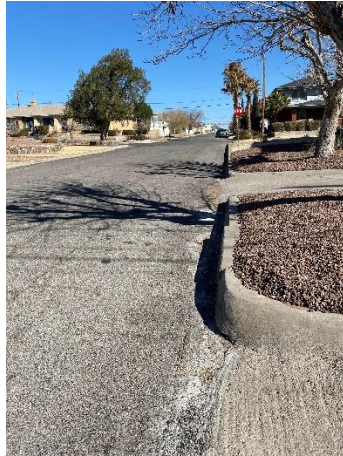
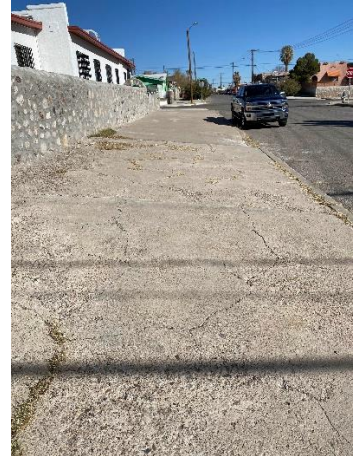
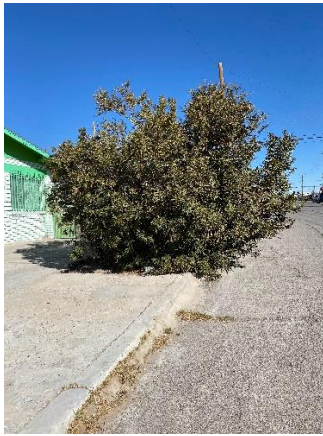
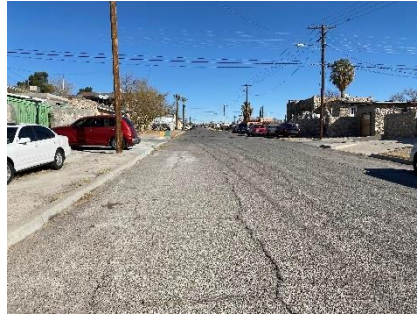
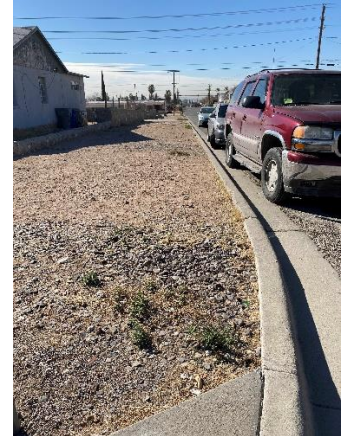
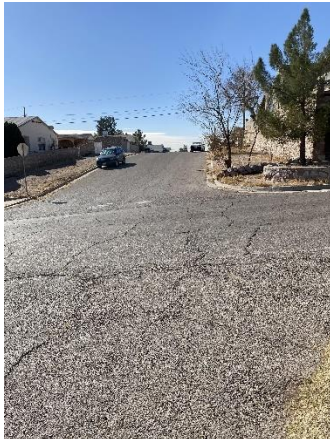
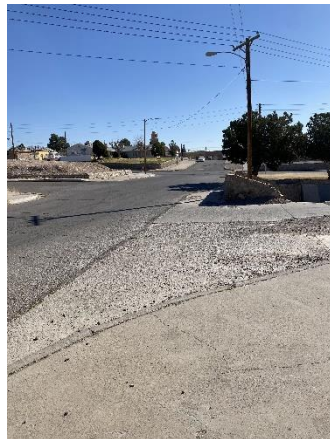
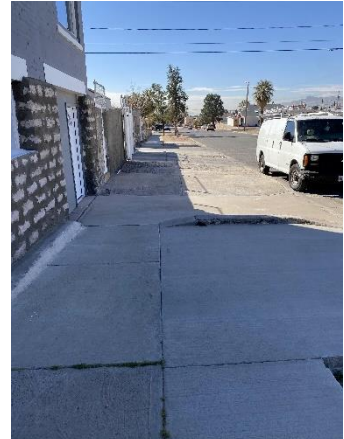
Driver Behavior	<ul style="list-style-type: none"> • Drivers are not looking out for people walking, make unexpected turns, or seem hostile. • This neighborhood has relatively low traffic, yet there are many parked cars that block access to safe crossing or force mobility users to use the street.
Overall, the quality and safety of driver behavior is:	Poor
Safety	<ul style="list-style-type: none"> • Objects or obstacles block pedestrian view. • There are abandoned or unkempt lots and/or structures. • The overall feeling safety is fair. However, the poor street design is unsafe and inaccessible for people using alternative mobility modes, such as walkers, wheelchairs, etc.
Overall, the feeling of safety in this area is:	Poor
Comfort and Appeal	<ul style="list-style-type: none"> • There are not enough street trees or other landscaping. • The street needs benches and places to rest. • Aside from the lack of adequate sidewalks and safe crossings, the route offers little shade and no rest areas.

<p>Sidewalks</p>	<ul style="list-style-type: none"> • No sidewalks or paths. • Sidewalks are broken, cracked, or have trip hazards. • Sidewalks are blocked by overgrown landscaping, poles, signs, plants, vehicles, etc. • Sidewalk is not continuous. • Sidewalk has nothing separating it from the street (grass, trees, parked cars.) • Sidewalk is inaccessible due to construction. • Aside from immediately around Memorial Park, sidewalks are either blocked, discontinuous, or not present entirely. In addition, there are obstacles, such as cars and debris on driveways and curbs. • The walk from Memorial Park to Austin High School is inaccessible for anyone with a mobility restriction and is dangerous for all users aside from cars.
<p>Overall, the quality and safety of sidewalks is:</p>	<p>Poor</p>
<p>Street Crossings and Intersections</p>	<ul style="list-style-type: none"> • The road is too wide to cross easily. • The crossing does not have a pedestrian-activated button, • There is no crosswalk, or it is poorly marked. • I must walk too far to find a safe, marked crosswalk, • Intersection does not have a curb ramp for carts, wheelchairs, strollers, walker, etc. • Curb ramps are inaccessible due to weeds, trash, sediment, etc. • There are no crosswalks at most intersections. • To get to Austin High School, one must cross Copia, a very wide street with no traffic calming measures and a faded cross walk. In addition, within the neighborhoods, the crossings are inaccessible for anyone using wheelchair or pushing a stroller. • Most of the time you must cross into the street and keep walking on the street.

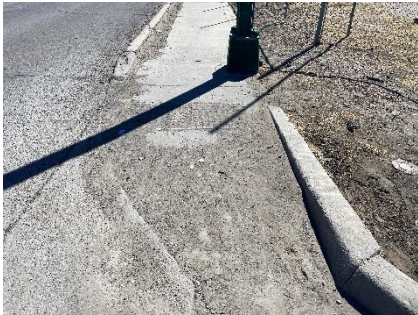
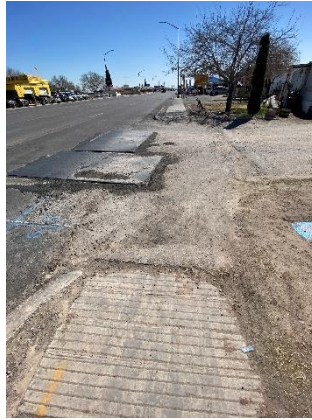
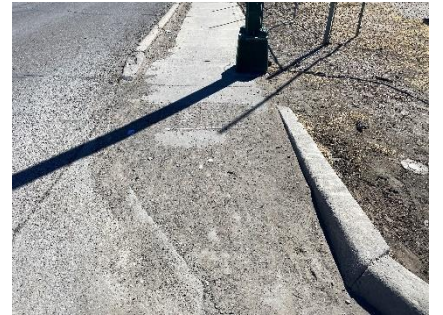
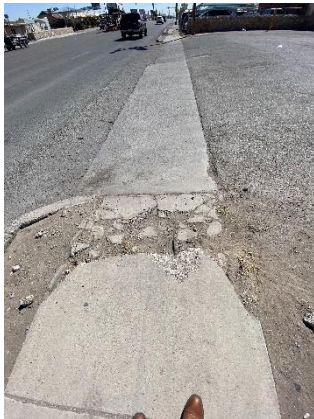
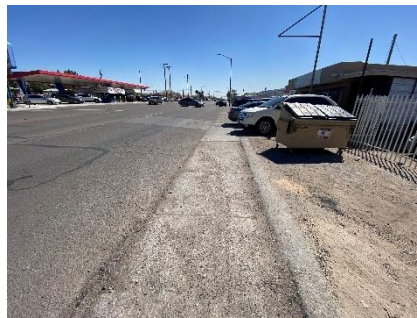
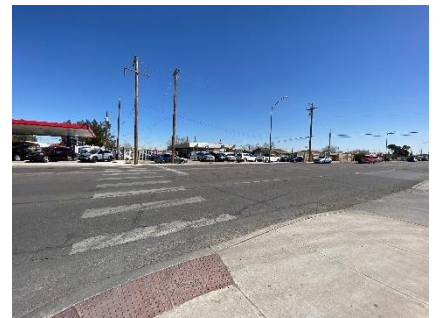
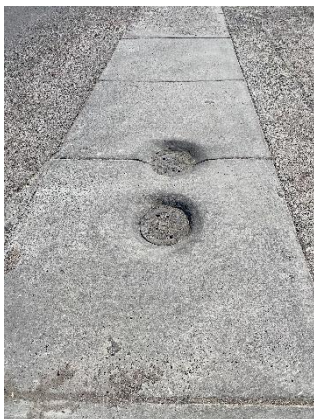
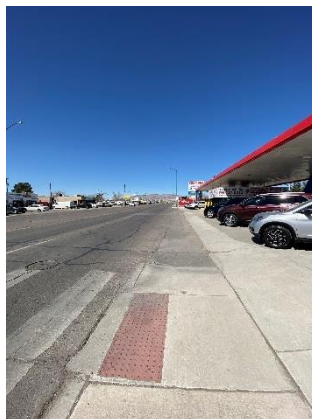
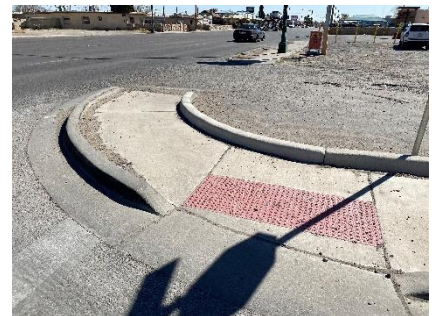
<ul style="list-style-type: none">• High traffic makes this area uninviting.
Overall, the feeling of safety in this area is:	Bad
Comfort and Appeal	<ul style="list-style-type: none">• There is not enough shade from canopies, awnings, or trees.• There are not enough street trees or other landscaping.• The street needs benches and places to rest.• The street needs public art and amenities to become more inviting.• No street trees or shade structures at all.• Public art would make this area more inviting.
Overall, the comfort and appeal in this area is:	Poor
Which of the following traffic calming elements would improve safety along your Street Audit route?	<ul style="list-style-type: none">• Splitter island• Textured/colored crosswalks:• Chicanes
Overall comments	Street seems very unsafe for pedestrians and inaccessible to individuals with disabilities.

Sidewalks	<ul style="list-style-type: none"> • No sidewalks or paths. • Sidewalks are broken, cracked, or have trip hazards. • Sidewalks are blocked by overgrown landscaping, poles, signs, plants, vehicles, etc. • Sidewalk is not continuous. • Sidewalk has nothing separating it from the street (grass, trees, parked cars.) • Uneven sidewalks with varying materials. Some parts have ADA accessibility, but the majority has poles blocking the ways or other trip hazards
Overall, the quality and safety of sidewalks is:	Bad
Street Crossings and Intersections	<ul style="list-style-type: none"> • The road is too wide to cross easily. • The crossing does not have a pedestrian-activated button. • There is no crosswalk or it is poorly marked. • I have to walk too far to find a safe, marked crosswalk. • Curb ramps are inaccessible due to weeds, trash, sediment, etc. • No safe crossings at all, some sidewalks are blocked by dirt and trash.

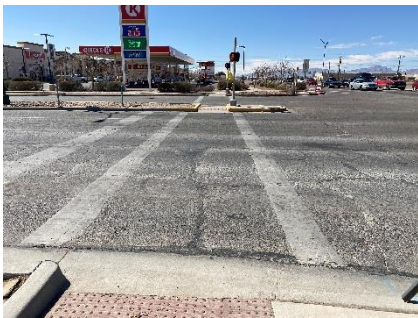
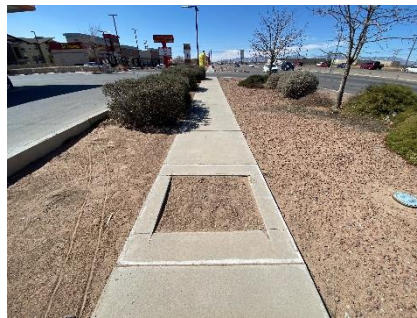
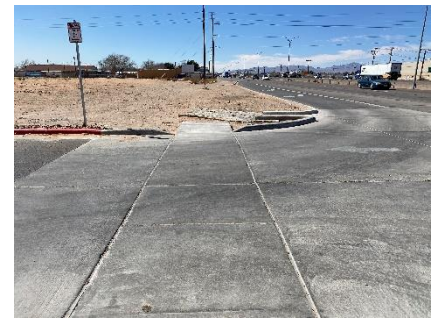
<p>Comfort and Appeal</p>	<ul style="list-style-type: none"> • There is not enough shade from canopies, awnings, or trees. • There are not enough street trees or other landscaping. • The street needs benches and places to rest. • The street needs public art and amenities to become more inviting. • Some areas had street trees, but the vast majority of the area had no street trees or shade structures.
<p>Overall, the comfort and appeal in this area is:</p>	<p>Bad</p>
<p>Which of the following traffic calming elements would improve safety along your Street Audit route?</p>	<ul style="list-style-type: none"> • Splitter island • Textured/colored crosswalks <p>Chicanes:</p>
<p>Overall Comments</p>	<p>The lack of sidewalks makes this highly transited area unsafe and inaccessible for individuals with disabilities.</p>

Ending Address/Intersection	Montana Ave. and Tierra Este Rd., El Paso, TX 79938
Sidewalks	<ul style="list-style-type: none"> • No sidewalks or paths. • Sidewalks are broken, cracked, or have trip hazards. • Sidewalks are blocked by overgrown landscaping, poles, signs, plants, vehicles, etc. • Sidewalk is not continuous. • For most of the audit there were no sidewalks; however, whenever there was a sidewalk present, ADA ramps were available.
Overall, the quality and safety of sidewalks is:	Poor
Street Crossings and Intersections	<ul style="list-style-type: none"> • The road is too wide to cross easily. • Traffic signals do not give enough time to cross the street. • I have to walk too far to find a safe, marked crosswalk. • Time to cross the Montana / Rich Beem crosswalk was 20 seconds, too wide of a street for that time; however, it has a pedestrian island.
Overall, the quality and safety of street crossing and intersections is:	Bad

Bicycle Facilities	No bicycle facilities
Overall, the quality and safety of the bike facilities are:	Poor
Driver Behavior	<ul style="list-style-type: none"> • Drivers appear to be speeding • Some drivers appear to be speeding, making the walk uncomfortable
Overall, the quality and safety of driver behavior is:	Bad
Safety	<ul style="list-style-type: none"> • Car speeds are too fast. • There is too much traffic. • There are vacant lots or rundown buildings. • There are abandoned or unkempt lots and/or structures. • Several unkept lots can be seen here that significantly affects the sense of safety.
Overall, the feeling of safety in this area is:	Bad

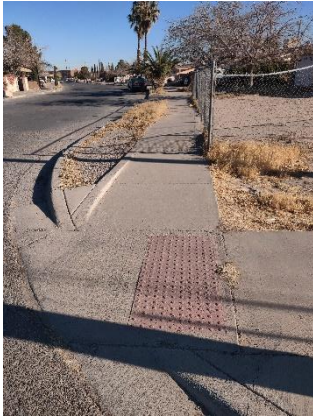
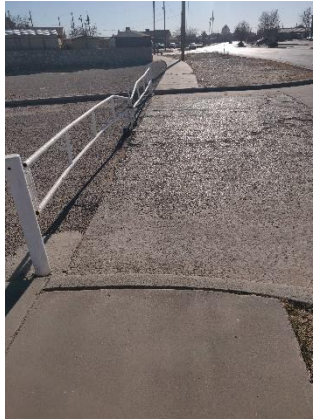
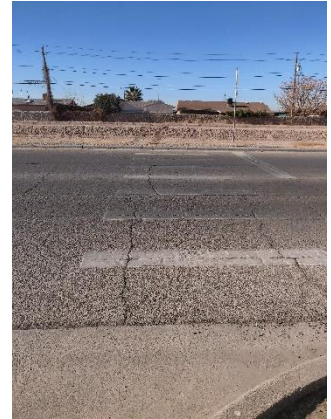
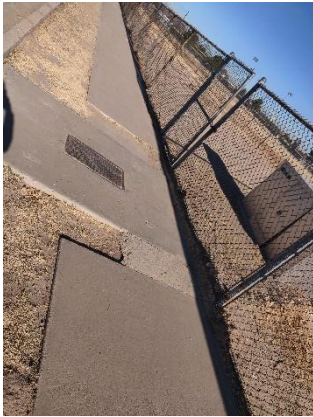
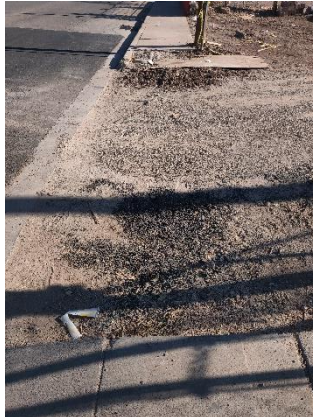
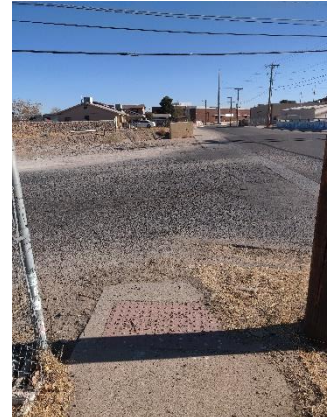
Sidewalks	<ul style="list-style-type: none"> Sidewalks in good condition overall, minor trip hazards near driveways, saw someone running on the sidewalk and on to the Playa Drain Trail
Overall, the quality and safety of sidewalks is:	Good
Street Crossings and Intersections	<ul style="list-style-type: none"> The crossing does not have a pedestrian-activated button. There is no crosswalk or it is poorly marked. I have to walk too far to find a safe, marked crosswalk. Ramp at Coloma is very steep and no striped crosswalk. No directional ramp between trail and liberty.
Overall, the quality and safety of street crossing and intersections is:	Good
Bicycle Facilities	<ul style="list-style-type: none"> No bike facilities, pavement condition appears to be in decent condition and would provide adequate ride quality for cyclists if sharrows were implemented
Overall, the quality and safety of the bike facilities are:	Poor

Driver Behavior	<ul style="list-style-type: none"> Drivers appear to be speeding. Mid-block chokers/chicanes would help to slow down vehicles outside of the school zone
Overall, the quality and safety of driver behavior is:	Good
Safety	<ul style="list-style-type: none"> Car speeds are too fast There are signs to alert drivers of pedestrians and bike riders
Overall, the feeling of safety in this area is:	Great
Comfort and Appeal	<ul style="list-style-type: none"> There is not enough shade from canopies, awnings, or trees. There are not enough street trees or other landscaping. The street needs benches and places to rest. The street needs public art and amenities to become more inviting
Overall, the comfort and appeal in this area is:	Neutral
Which of the following traffic calming elements would improve safety along your Street Audit route?	<ul style="list-style-type: none"> Intersection bulbouts Textured/colored crosswalks Chicanes

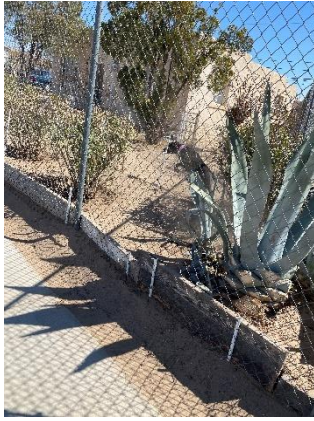
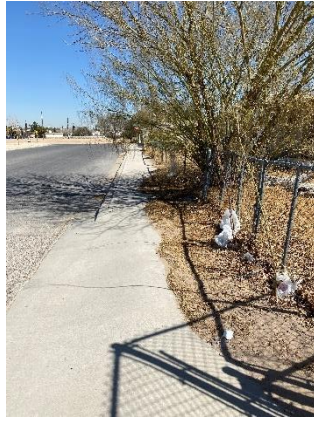
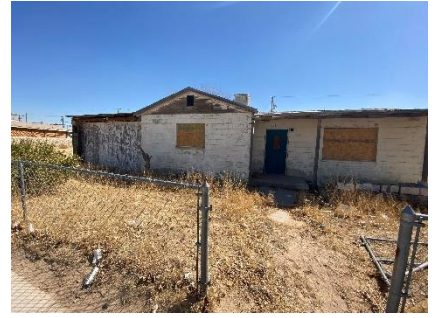
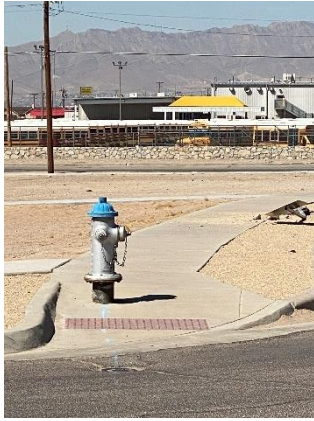
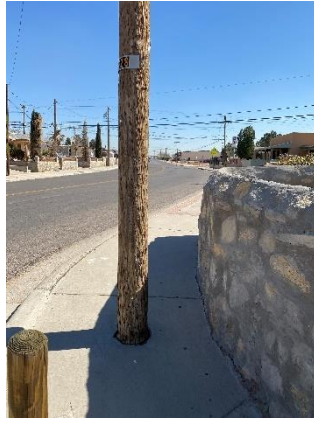
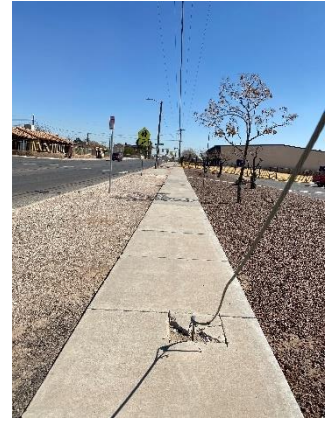
Sidewalks	<ul style="list-style-type: none"> • Sidewalks are broken, cracked, or have trip hazards. • Sidewalks are blocked by overgrown landscaping, poles, signs, plants, vehicles, etc. • Sidewalk has nothing separating it from the street (grass, trees, parked cars.) • Some ADA ramps have bumps that make it inaccessible and some parts of the sidewalk are too steep for a wheelchair.
Overall, the quality and safety of sidewalks is:	Neutral
Street Crossings and Intersections	<ul style="list-style-type: none"> • The road is too wide to cross easily. • There is no crosswalk or it is poorly marked. • I have to walk too far to find a safe, marked crosswalk. • Not enough marked crosswalks and streets are wide enough to fit a bike lane.
Overall, the quality and safety of street crossing and intersections is:	Neutral
Bicycle Facilities	No facilities for bike lanes
Overall, the quality and safety of the bike facilities are:	Poor

Overall, the comfort and appeal in this area is:	Bad
Which of the following traffic calming elements would improve safety along your Street Audit route?	<ul style="list-style-type: none">• Splitter island• Textured/colored crosswalks
